Plant scan – Optimize AAC production by understanding cost drivers

AIRCRETE PLANT SCAN INSIGHTS

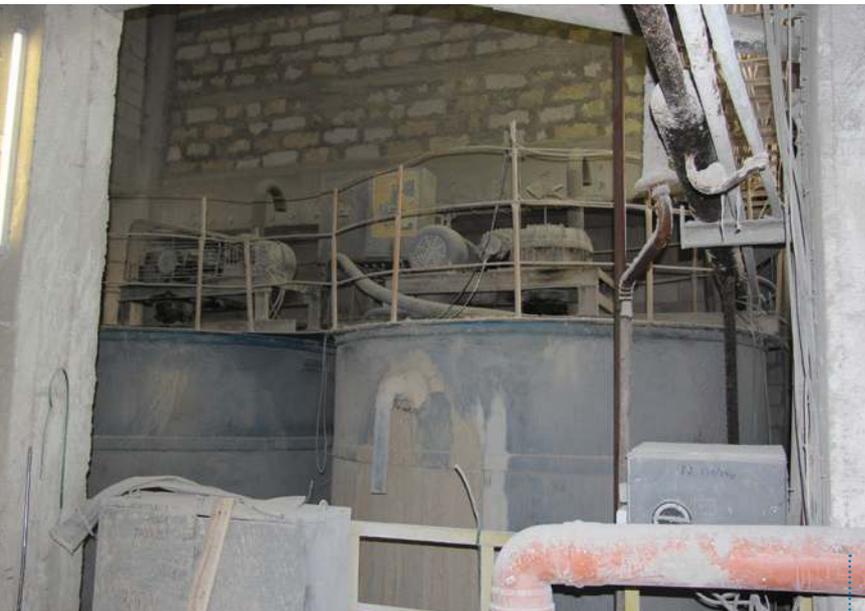
It was hard to keep the slurry density under control through manual measurements

Keeping the slurry density variation under control consistently was a major issue for the client. The measurements were executed manually by hand. The existing automatic controller was already shut down because it was not working properly.

Aircrete Plant Scan report recommended a load-cell based u-pipe system that would be integrated with the mixer control system.

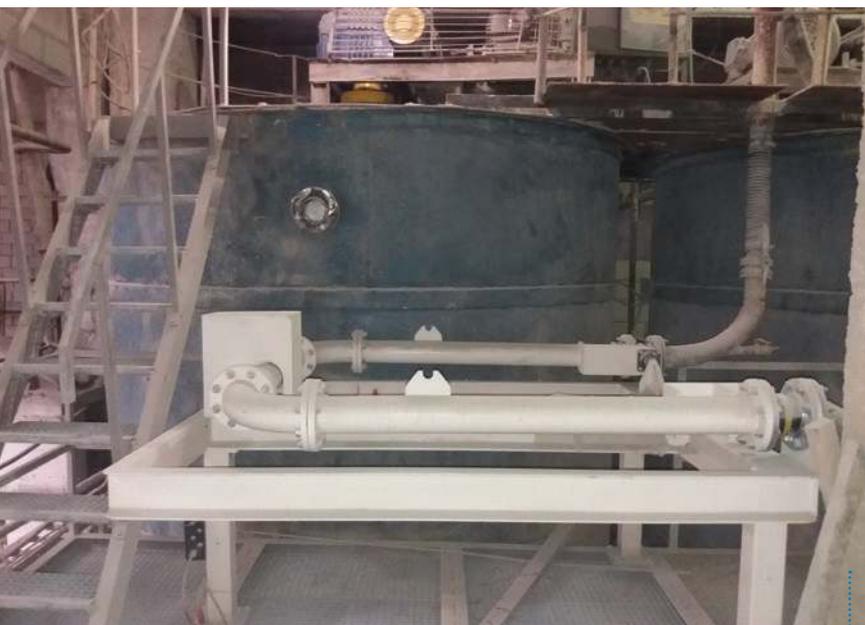
The u-pipes installed after plant scan are integrated with the mixer control system

Three u-pipe systems were installed to measure the fresh slurry, the return slurry and the cutting-pit slurry respectively. The accuracy of the process has drastically improved through automation and the formula changes automatically depending on actual measurement results.

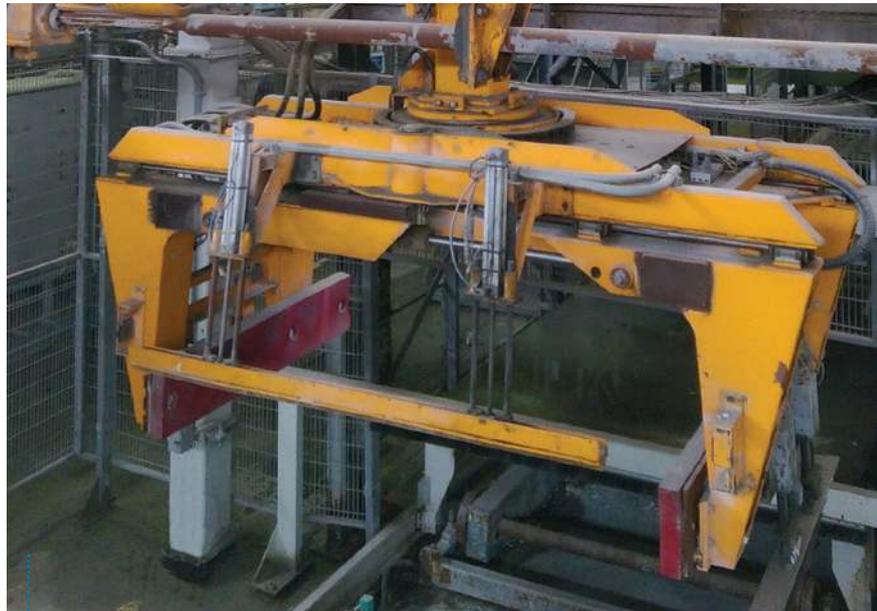
For around 40 % percent of the products, the existing gripper on the unloading line was not ideal for the new pack dimensions and caused high down-times and damage to the products. The gripper needed to be modified to be able to fit the same products on different sized pallets.

The old gripper on the unloading line was not able to hold new products

Aircrete Plant Scan report recommended an engineering assignment including a motor replacement of the gripper so that it can pick both the old and new sized pallets up.

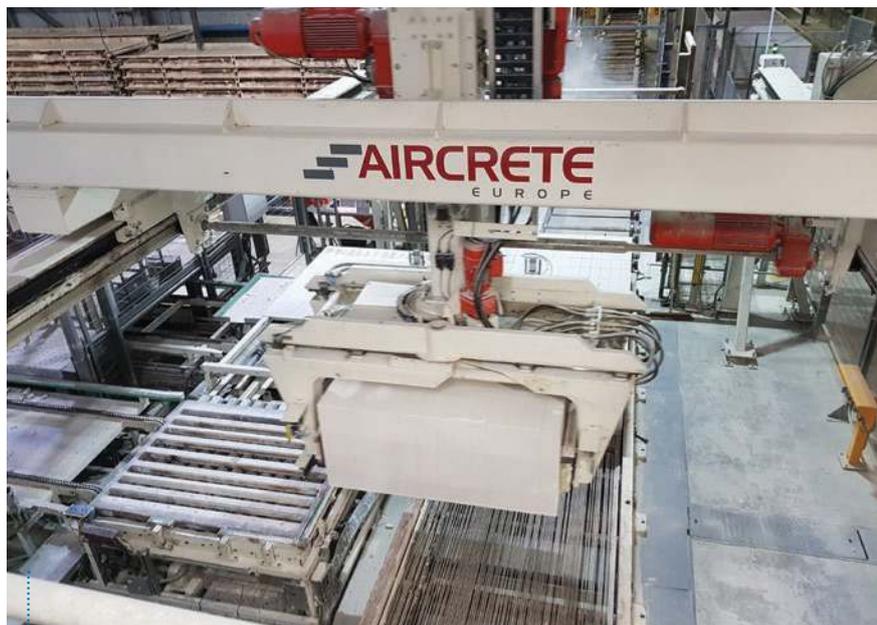
The customer received a detailed engineering re-work plan with indicative budgets so that they can choose among options from different solution providers. In the end, the project was outsourced to Aircrete Europe and was delivered in a couple of weeks.

Replacement of the gripper after plant scan enabled heavier products to fit on the pallets

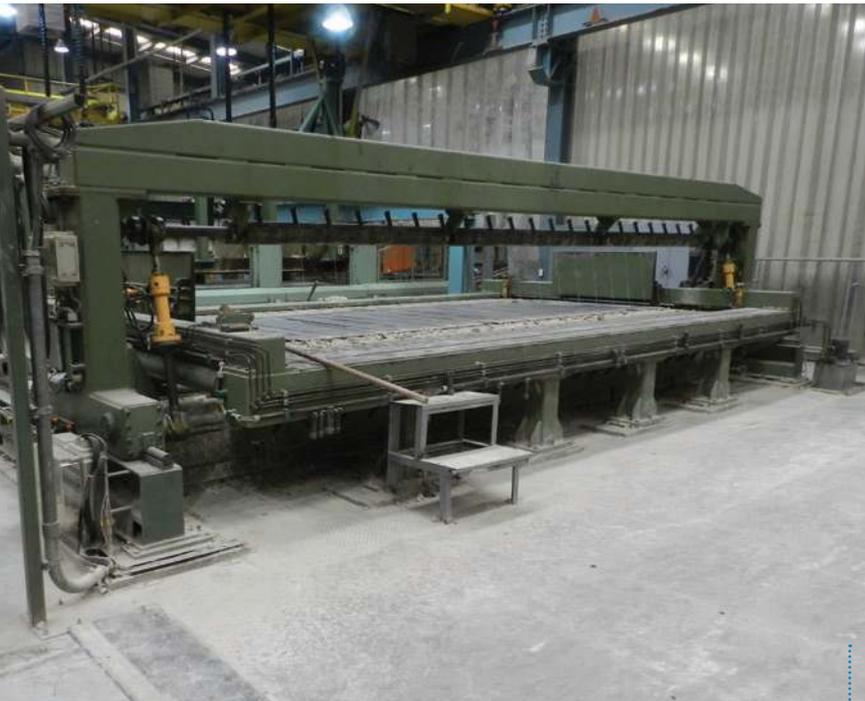
The cutting line was not suitable for products with 5 mm incremental thicknesses and super smooth surfaces

The existing technology was outdated for the new product portfolio they wanted to make with 5 mm incremental thicknesses and super smooth surfaces.

Aircrete Plant Scan report recommended the replacement of the whole cutting line while not having to change the existing plant infrastructure at all.

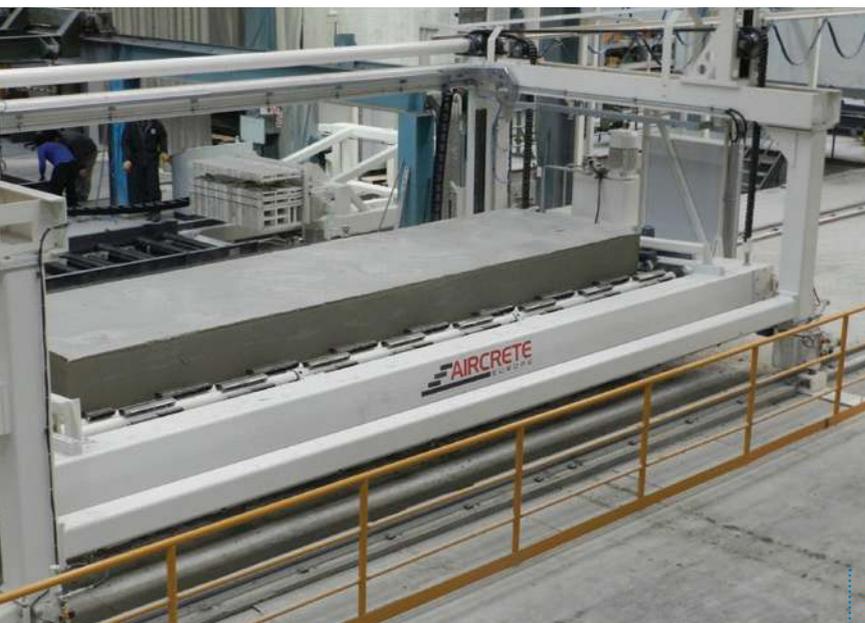
The new cutting line was successfully integrated with the plant's existing infrastructure

As the customer gained trust and felt confidence with Aircrete Europe`s approach and staff, the implementation of the new cutting line was realized shortly. The project was executed with a detailed engineering work to keep the infrastructure changes at zero level. The relationship that started with Aircrete Plant Scan turned into a full-scale modernization of the plant. The second phase of the project involves a capacity increase, further plant automation, additional technology supply and continuous support.
